Burst Testing of Filament-Wound Graphite-Epoxy Composite Cylindrical Tubes

1 November 2002

D. J. CHANG, H. A. KATZMAN, J. P. NOKES, P. M. ADAMS,
S. T. AMIMOTO, P. R. VALENZUELA,
T. V. ALBRIGHT, and P. L. JOSEPH
Space Materials Laboratory
Laboratory Operations

SPACE AND MISSILE SYSTEMS CENTER
AIR FORCE SPACE COMMAND
2430 E. El Segundo Boulevard
Los Angeles Air Force Base, CA 90245

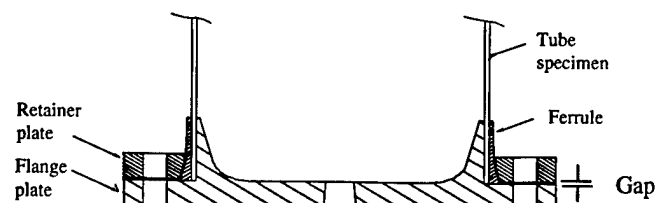
Figure 3.1. Cross-section sketch of end fitting.

The end fittings used for this program are an improved version of those designed and used for earlier testing.^{3.1,3.2} The basic concept is to apply a radial compression to the end fitting insert/tube interface. This compression generates a mechanical friction force (or shear force) when the tube and the end fitting are being pulled apart longitudinally. This increases the shear strength capability of the end fitting by an amount equal to the product of the compressive stress, the friction coefficient, and the contact area between the tube and the insert. Figure 3.1 shows the design of the end fitting used to generate the radial compression. The fixture includes a circular flange plate with an inner insert, a ferrule, and a retainer plate with an outer diameter equal to that of the flange. The ferrule has a tapered thickness such that it is thicker toward the base and thinner at the tip. The thin section at the tip gives high radial compliance to limit stress concentrations between the ferrule and the tube that may induce early failure. The retainer plate has an inner diameter slightly smaller than the outside diameter of the ferrule so they interfere. Both the flange and the retainer plates have 16 holes aligned at the same radial and angular locations. In assembling the fitting, the inner surface of the tube is first bonded to the outer surface of the inner insert. The outer surface of the tube is then bonded to the inner surface of the ferrule. The interference between the retainer plate and the ferrule introduces a gap between the retainer plate and the flange. These two components are then forced to contact by tightening the 16 bolts through the holes. This procedure brings the ferrule, the tube, and the inner insert in radial compression. The radial compression increases the shear strength between the tube and the end fitting by an amount equal to μNA where μ is the frictional coefficient, N is the normal compressive stress, and A the total contact area between the tube and the ferrule and between the tube and the inner insert. The estimated values of μ , N , and A are: $\mu = 0.25$ to 0.4 ; $N = 8000$ psi; and $A = 25.0$ in². These give allowable internal pressures between 4000 and 6300 psi. The adhesive between the epoxy and the stainless steel has a shear strength of 4000 psi. A combination of the shear strength from compression-induced friction and the adhesive bonding gives the necessary shear-load-carrying capability to the tube/end fitting assembly against end fitting slippage. This design operated flawlessly at pressures of nearly 8000 psi in our testing. Figure 3.2 depicts a specimen with end fittings assembled.

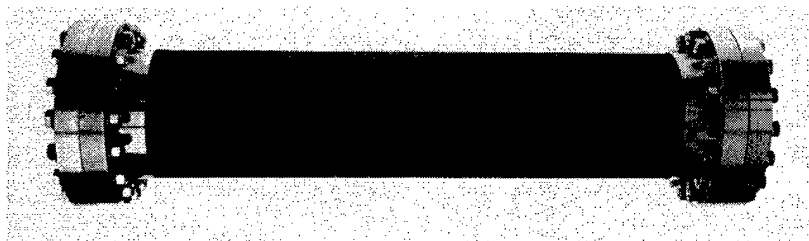
Figure 3.2. Outside view of tube specimen with end fitting.

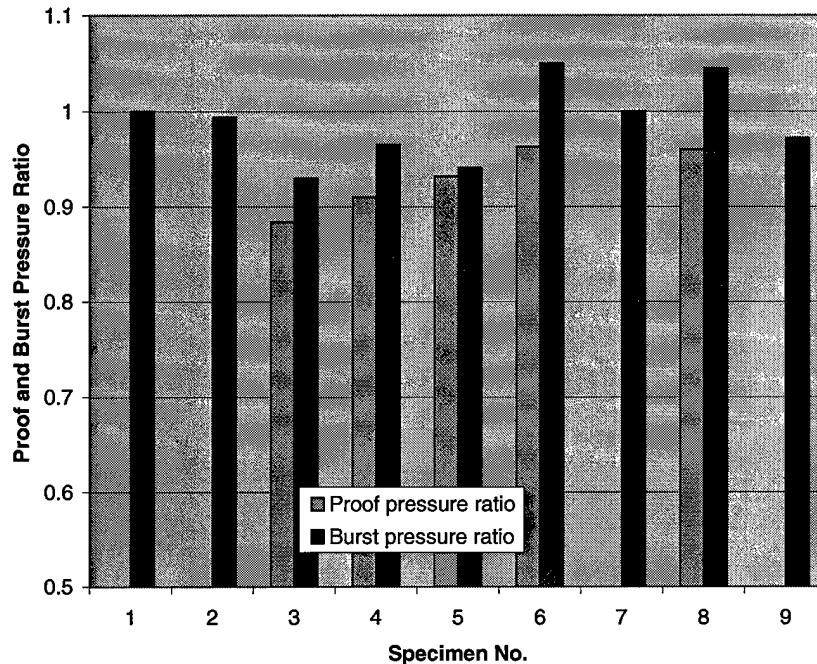
Figure 4.1. Bar charts showing the ratios of proof and burst test pressures for Test Series I. (Average burst pressure of baseline tubes is 2860 psi.)

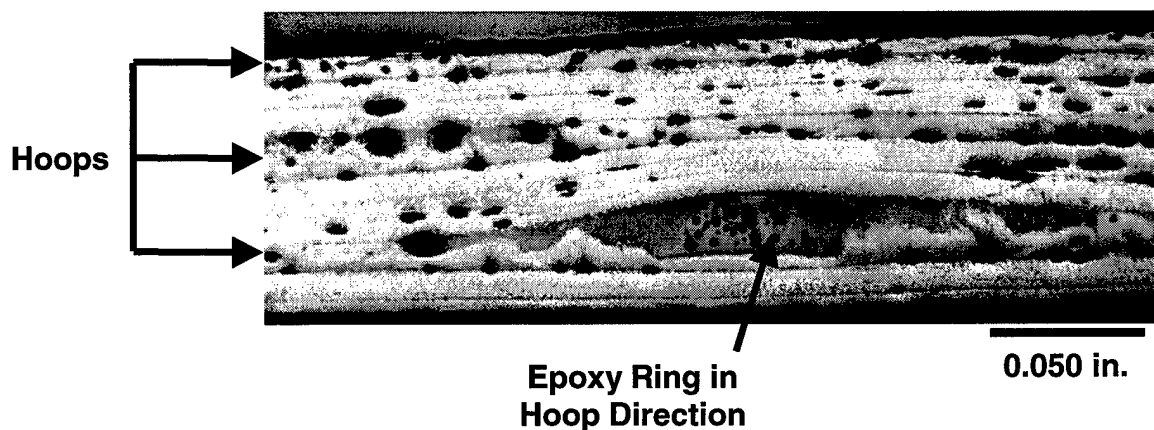
Figure 4.4. Cross-sectional view at wrinkle of a helically wrinkled tube.

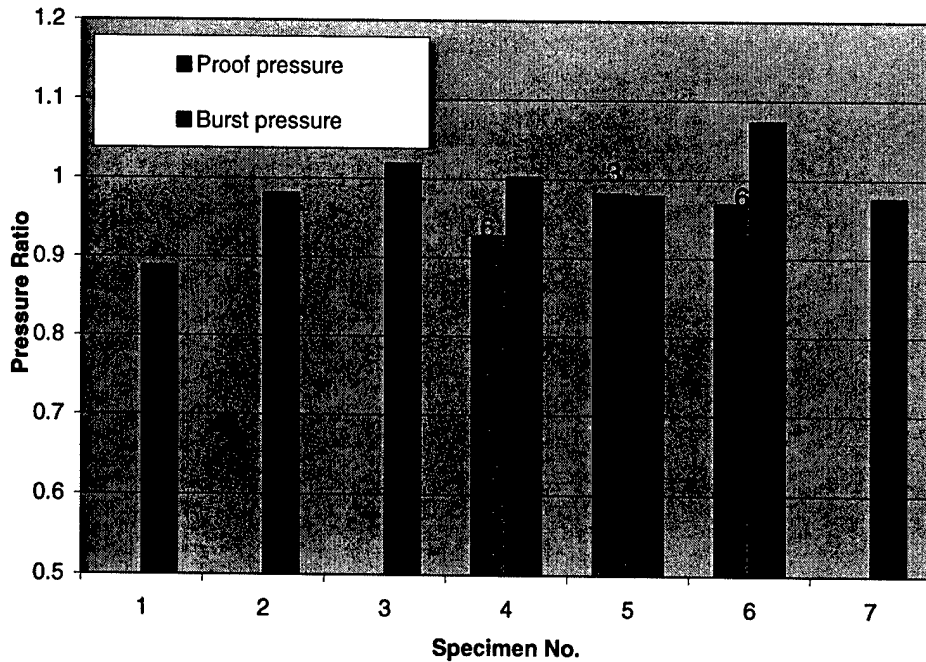
Figure 4.5. Bar charts showing proof and burst test ratios for Test Series II. (Average burst pressure of baseline tubes is 3005 psi.)

The results of Test Series II are shown in Table 4.4. The average burst pressure was 3005 psi. Figure 4.5 depicts bar charts showing the ratios of proof and burst pressures for Series II. The number

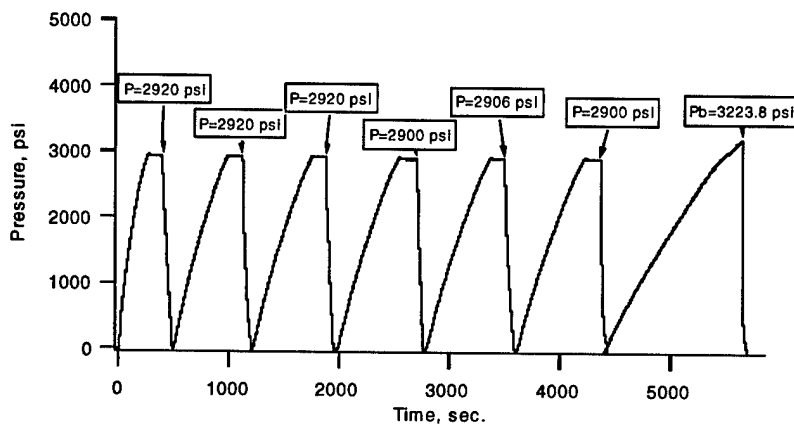
Figure 4.6. Pressure-time history for Specimen II-6.

The six wrinkled segments were tested in two conditions: three were pressurized directly to burst, and three were proof tested before burst. For each proof cycle, the peak pressure was maintained for 2 min before venting. As seen in Table 4.4, there were no differences in burst pressures between proof-tested and un-proof tested specimens other than typical data scatter for composite materials. A typical pressure-time history plot is depicted in Figure 4.6.

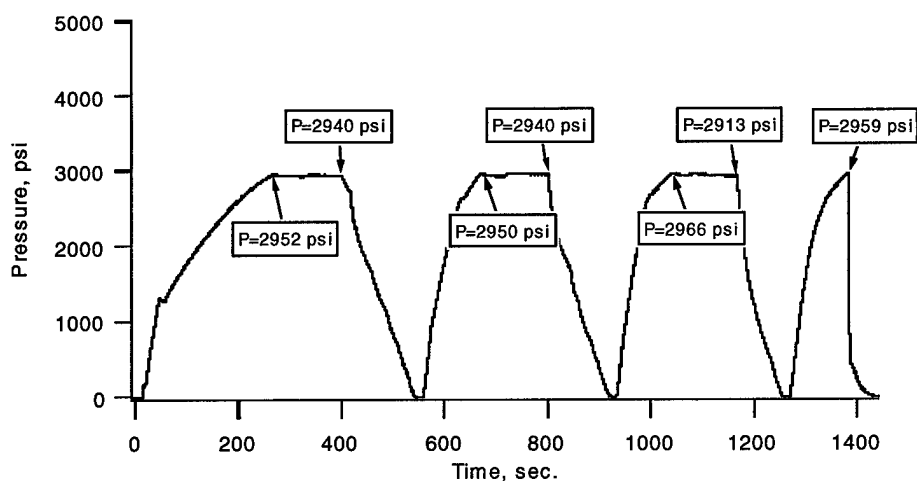
Figure 4.7. Pressure-time history for Specimen II-5.

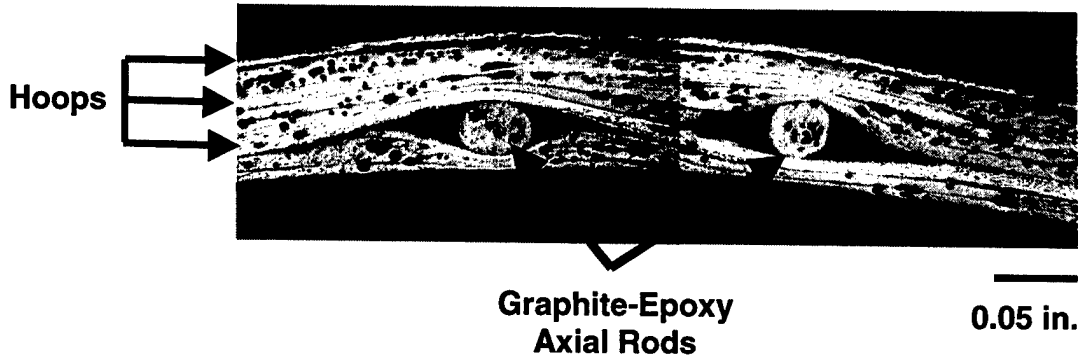
Figure 4.8. Cross section view at wrinkle of a hoop wrinkled tube.

In this test series, six 15-in.-long segments with hoop wrinkles and two 15-in.-long unwrinkled segments were cut from an 11-ft-long tube. Only 5 of the 6 wrinkled tubes were burst. The fiber lay-up angles in the tube were the same as those in the Test Series I and II tubes. The two unwrinkled segments served as the baseline, and the average burst pressure from the two unwrinkled segments was 2992 psi. The unwrinkled segments were cut from the middle portion of the 11-ft-long tube. The hoop wrinkles were created using two 8-in.-long graphite/epoxy rods fully cured in advance. The two rods ran longitudinally and were symmetrically located in the middle portion of each segment. One rod was below and the other was above the second hoop layer. The wrinkle weakened the load-carrying capability of the tube in the hoop direction. Figure 4.8 depicts a cross-section of a hoop-wrinkled tube.

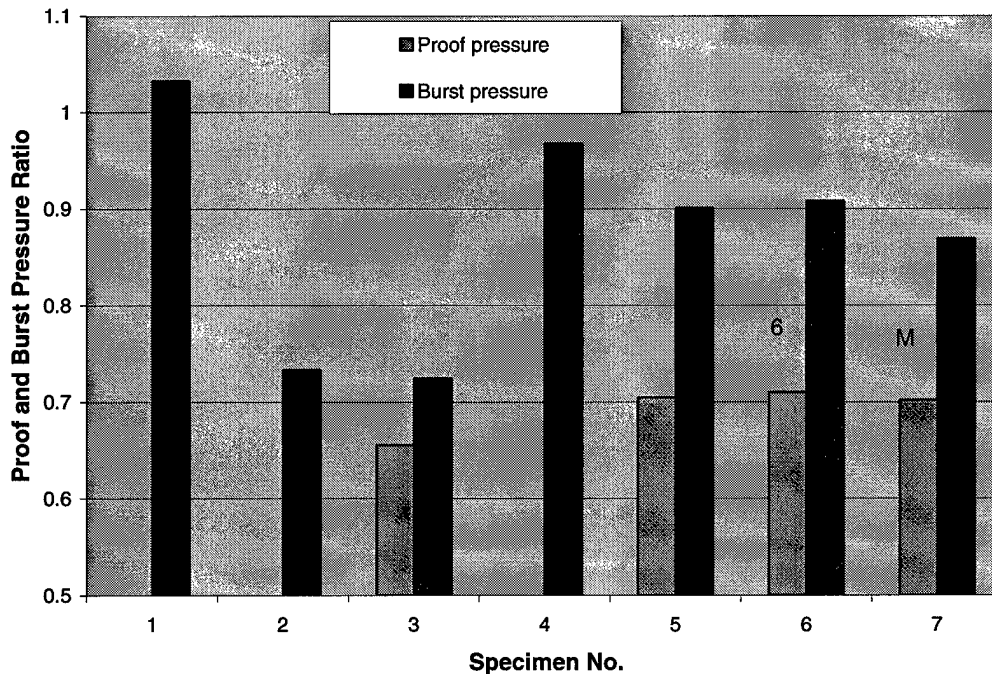
Figure 4.9. Bar charts showing the ratios of proof and burst test pressures for Test Series III. (Average burst pressure of un-wrinkled tube is 2992 psi.)

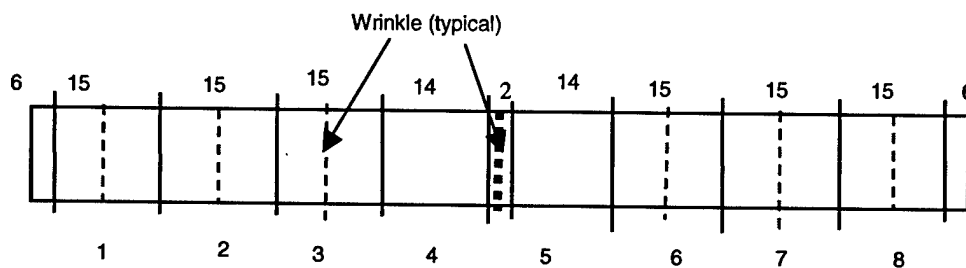
Figure 4.11. Sketch showing the tube specimen configuration and wrinkle locations. The top numbers are length in inches.

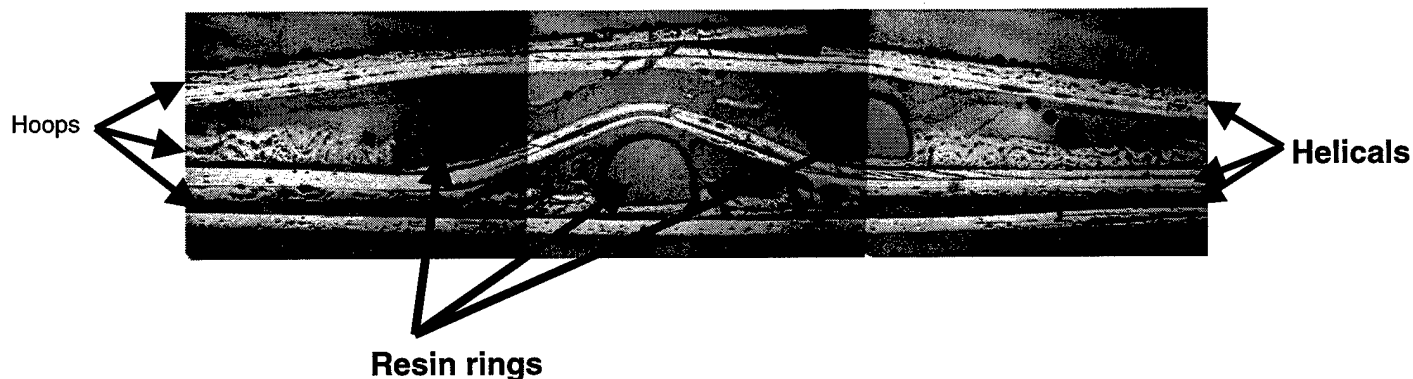
Figure 4.12. Typical cross section of a helical wrinkle for Tube IV. (From post-test piece of Test IV-4.)

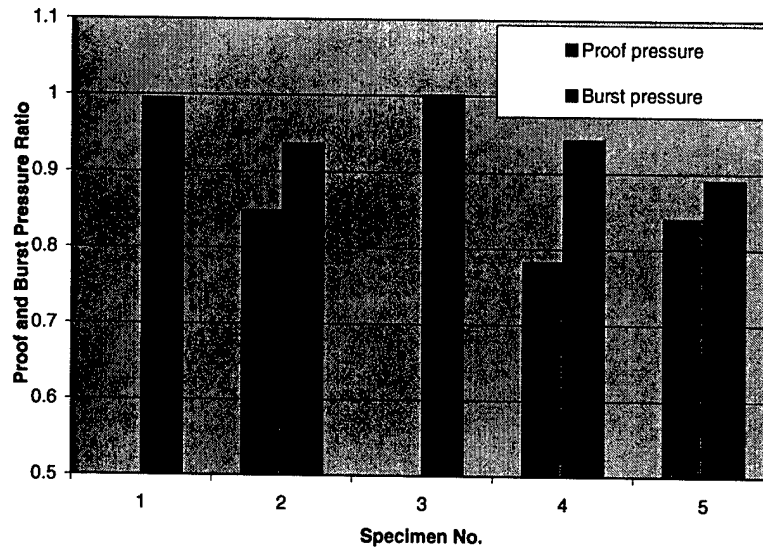
Figure 4.13. Bar charts showing proof and burst test ratios for Test Series IV.
(Average burst pressure of un-wrinkled tube is 7653 psi.)

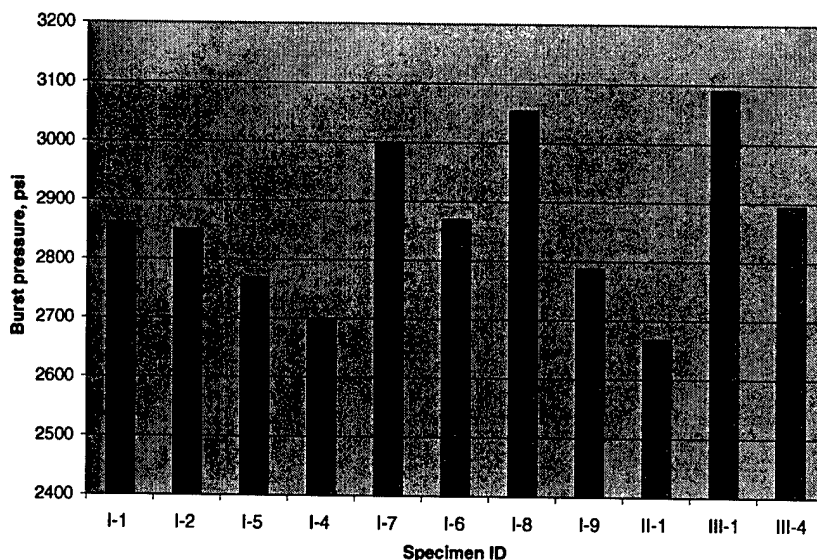
Figure 4.17. Burst pressures for all flaw-free specimens from Test Series I, II, and III.

The average burst pressure of 11 tested flaw-free tubes from Series I, II, and III was 2860 psi with a standard deviation of 137 psi or 4.8%. Figure 4.17 depicts the burst pressures of these 11 specimens. The 6 tubes with the minor helical wrinkle had an average burst pressure of 3022 psi with a standard deviation of 109 psi or 3.6%. The tubes with hoop wrinkles had an average burst pressure of 2475 psi with a standard deviation of 271 psi or 11.0%. Test conditions included straight burst testing, single proof tests followed by burst, and multiple proof tests followed by burst. Some of the tubes were proof tested to levels as high as 98% of the average burst pressures, and some were cycled to these proof pressures as many as six times before bursting.

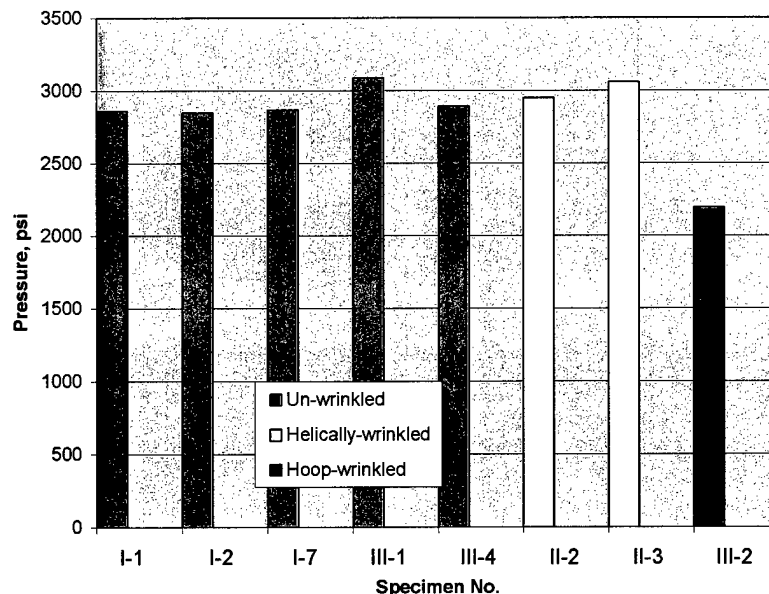
Figure 4.18. Effects of wrinkles on burst pressure with no proof pressure.

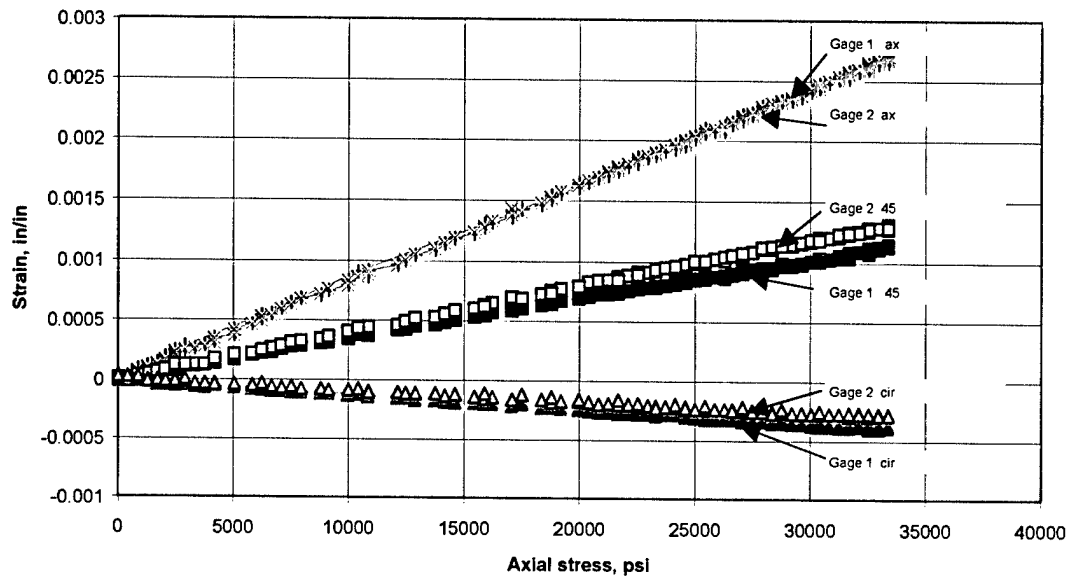
Figure 4.19. Uni-axial strain-stress for 2-in.-ID graphite-epoxy specimen.

The same rosette (0/45/90) type of strain gages (CEA-06-062UR-350) that were used in the 4-in.-ID specimens were mounted on the outside surface of the specimens. There were two gages on each specimen 180° apart at the middle of the specimen, designated as gage 1 and gage 2. For the uniaxial specimen, the 0° and 90° direction gages were parallel to the axial and hoop directions, respectively. In the torsion specimen, they were 45° from the axial and hoop directions in order to record the maximum strain readings. The stress-strain curve for the uni-axial specimen is depicted in Figure 4.19. In Figure 4.19, gage 1 ax, gage 1 45, and gage 1 cir refer to the gage No. 1 in the axial direction, 45° from the axial direction, and circumferential direction, respectively. The same notations apply to gage No. 2. The torsion stress-strain curve is depicted in Figure 4.20. The calculated Young's modulus, E , and the shear modulus, G , are 12.5 msi and 1.10 msi, respectively. The Poisson's ratio (hoop strain to axial strain under axial stress) is 0.13.

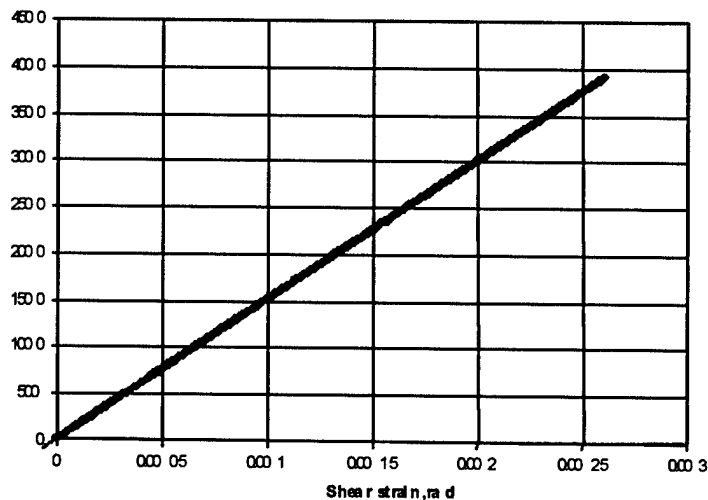
Figure 4.20. Shear stress-strain curve for 2-in.-ID graphite-epoxy specimen.

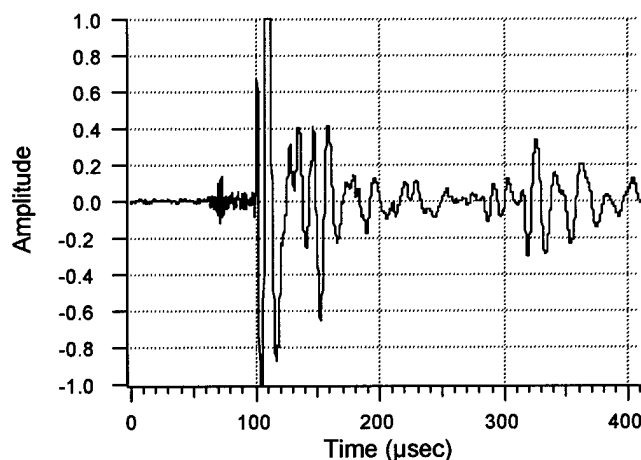
Figure 5.1. Example of a calibration AE event.

A Digital Wave Corporation 6-channel AE system was utilized for the acoustic monitoring of the composite tubes. The Digital Wave instrument consists of pre-amplifiers, signal filters, a triggering system, and a wideband receiver interfaced into a computer. The Digital Wave system records the complete AE signal or "wave" for each detected event. An example of a typical AE signal is provided in Figure 5.1.

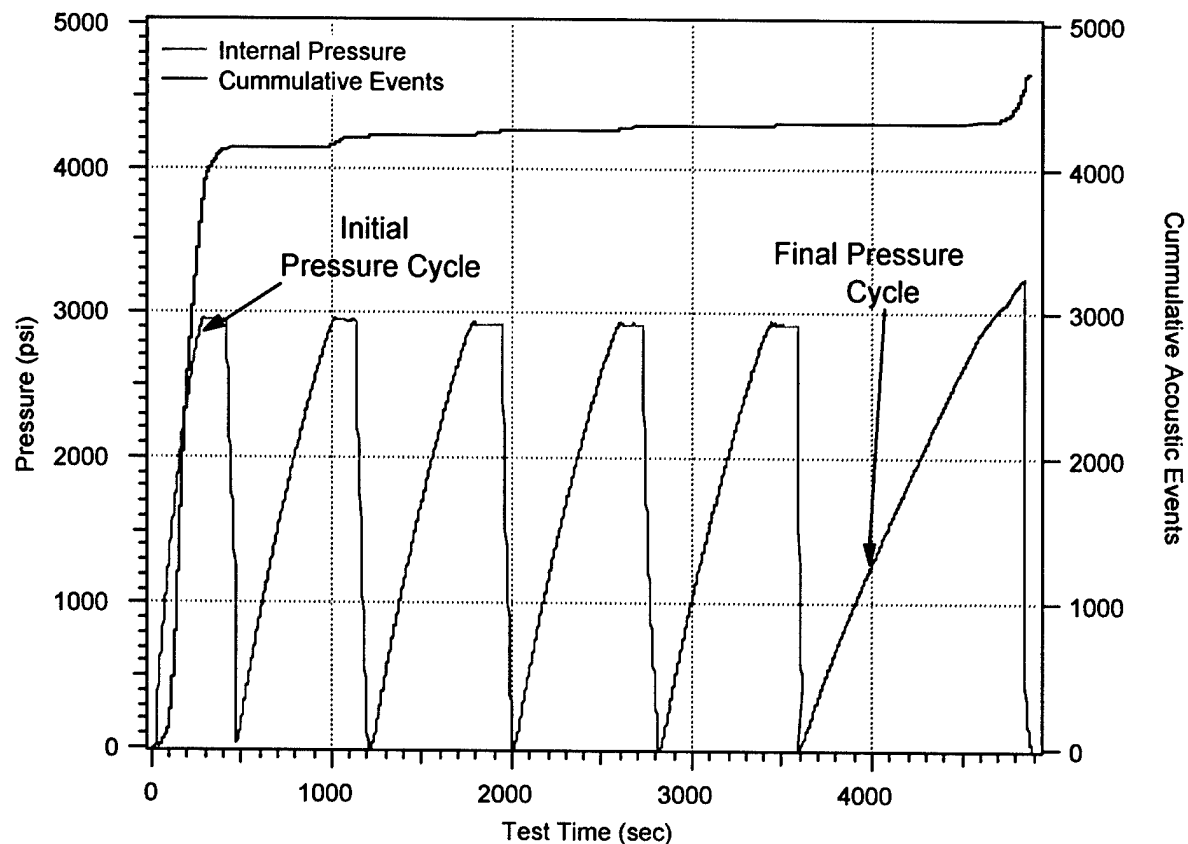
Figure 5.4. Acoustic emission recorded while pressure cycling Tube # II-6.

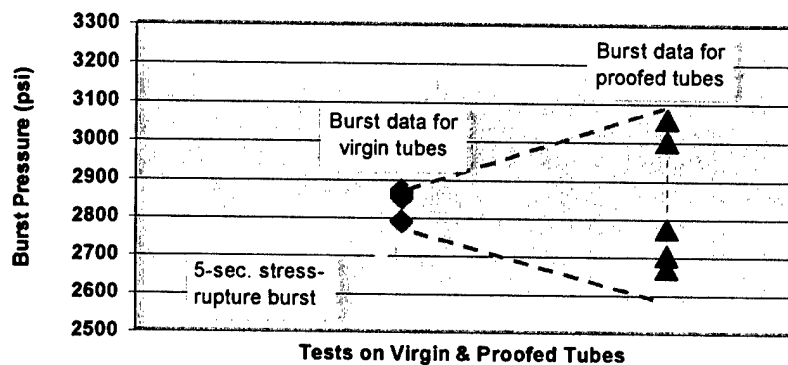
Figure 6.1. Burst data for tubes w/o wrinkles.

However, there is another interpretation for the data in Figure 6.1. This second hypothesis states that the difference between the two groups of data is real, as indicated by the wide dispersion in the data scatter. According to this second hypothesis, the two groups are not drawn from the same population, and the proof test does affect the tube behavior. At first sight, the idea is puzzling because of the trend lines (green dotted lines) shown in Figure 6.1. If the trend is real, then some of the tubes would have to become stronger after the proof test (while others become weaker). A possible explanation for this behavior lies in the geometric shape of the tubes. When the tubes are fabricated, they are wound and cured on a circular mandrel. They are then cooled and removed from the mandrel. Ideally, they should remain circular, but it is well known that composite materials can warp or change shape after thermal processing. Such warpage is usually caused by non-uniform internal stresses resulting from curing and thermal contraction. As a result, some of the tubes may not be perfectly round after they are removed from the mandrel. The “circularization” hypothesis argues that the

The burst data for seven unwrinkled tubes are in shown in Table 6.6. This table extends the data in Figure 6.1 (blue diamonds) by adding an extra five burst tests. The extra tests were also on virgin tubes without wrinkles. Figure 6.2. shows the data in statistical form, where the x-axis represents internal pressure, and the y-axis plots the cumulative probability of failure. The Weibull curve that fits the data (dotted orange line) is associated with the following parameters: Weibull slope $m = 23.8$, and scale parameter $\sigma_0 = 2953$ psi. The fit is not unique, and it is possible to argue that “m” may

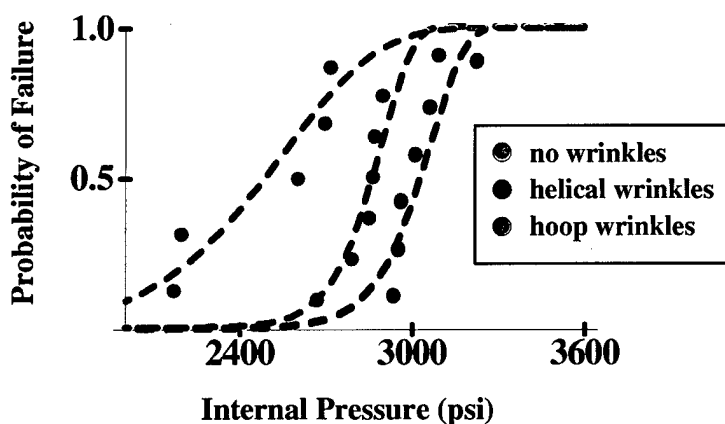
Figure 6.2. Weibull Plots for burst strengths of tubes.

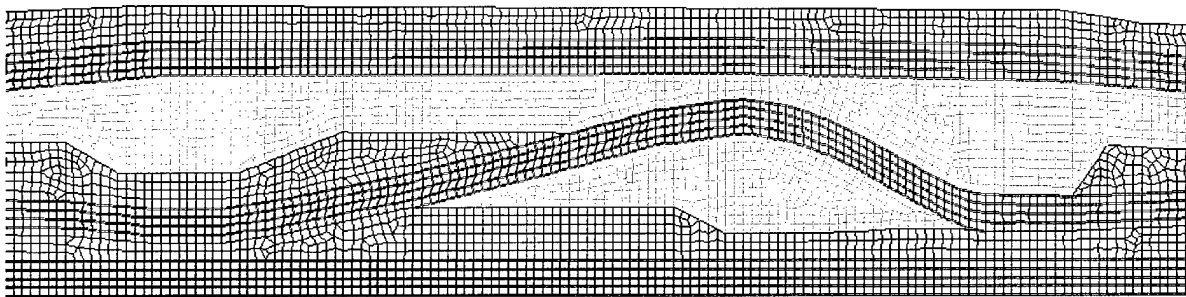
Figure 6.3. Finite-element model of tube with helical wrinkle.

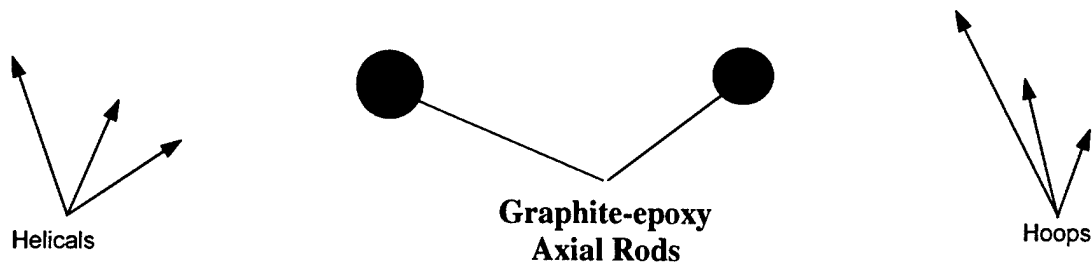
Figure 6.4. Finite-element model of 9-ply composite tube with hoop wrinkles.

The second FEM model looked at a large hoop wrinkle in a 9-ply tube (Figure 6.4). This model included two graphite-epoxy rods within the resin pockets of the composite. These were real rods that were placed into tubes in Series III to cause wavy distortions in the hoop fibers (see Figure 4.8). The model assumes that only the hoop fibers are wavy; the helical fibers remain straight. A generalized plane-strain analysis was used for this configuration, with the wrinkle placed at the middle of a 180° arc. The nodes at the ends of the arc were constrained from moving circumferentially, but were free to move radially under the influence of internal pressure. These boundary conditions are an approximation to the stress solution for the real cylinder. By applying symmetry conditions on the

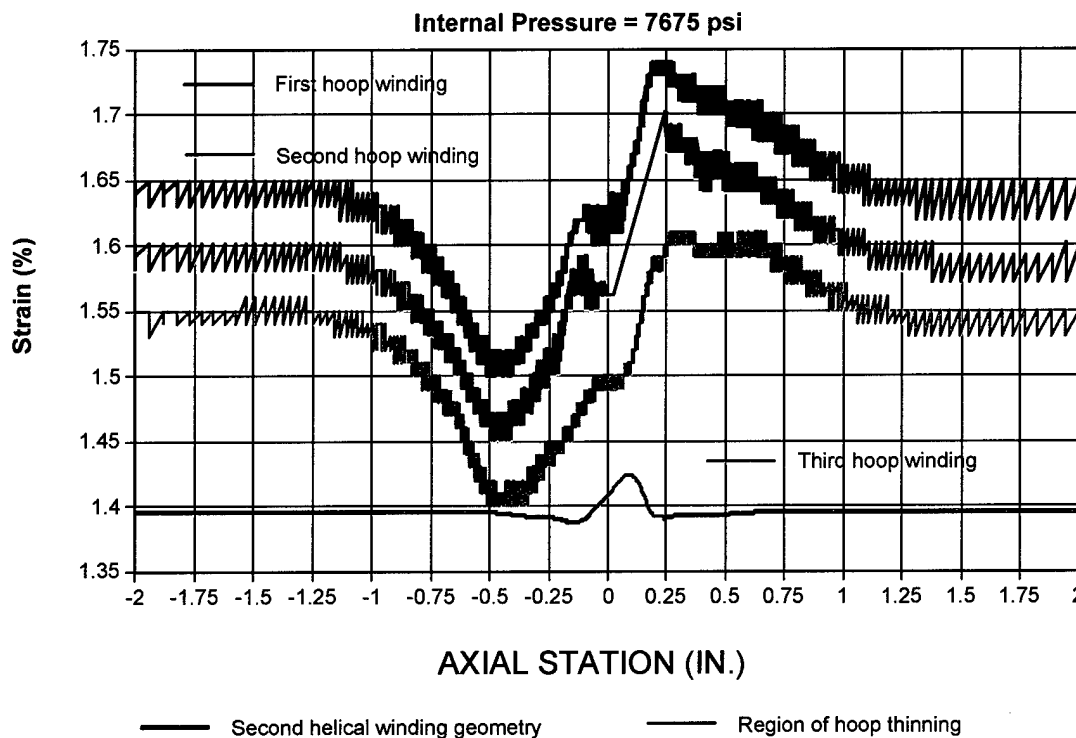
Figure 6.5. Predicted hoop strains in 12-ply tube with a helical wrinkle (Series IV).

At the location of the wrinkle, the FEM model predicts a maximum hoop strain of 1.74% at the innermost hoop ply underneath the right-hand side of the wrinkle. Hence, the strain concentration

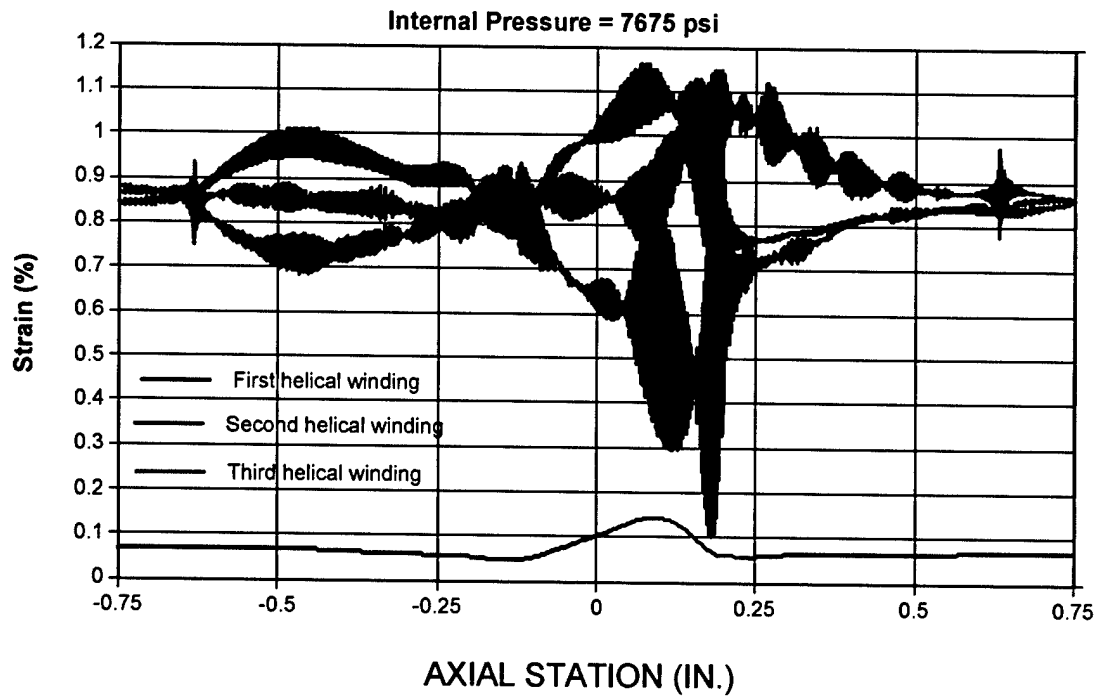
Figure 6.6. Predicted helical strains in 12-ply tube with a helical wrinkle.

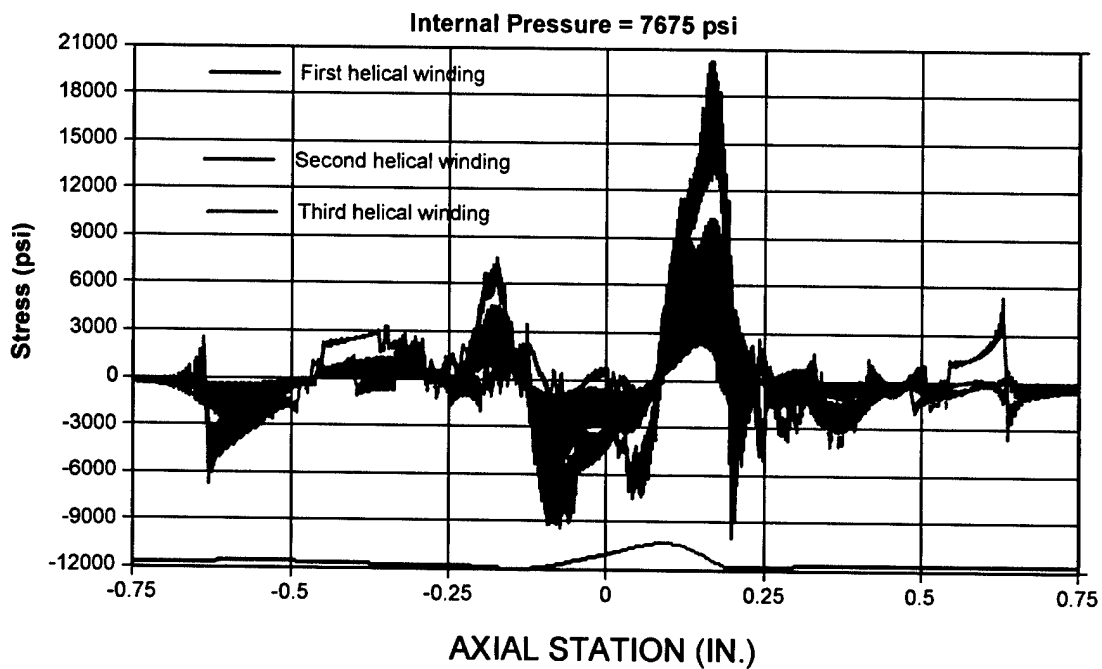
Figure 6.7. Predicted interlaminar shear stresses in 12-ply tube with a helical wrinkle.

The interlaminar shear stresses in the helical plies are shown in Figure 6.7. The stresses are fairly benign, except in the region of high curvature near the wrinkle. The large shear stresses could, in principle, induce a delamination. One of the puzzling aspects about the present investigation is why delamination cracks did not grow at the wrinkle under high loads. No significant AE emissions were recorded that could be associated with large-scale delamination growth. Other aspects of the tube failures, such as the high burst pressures, are also consistent with the absence of large-scale delami-

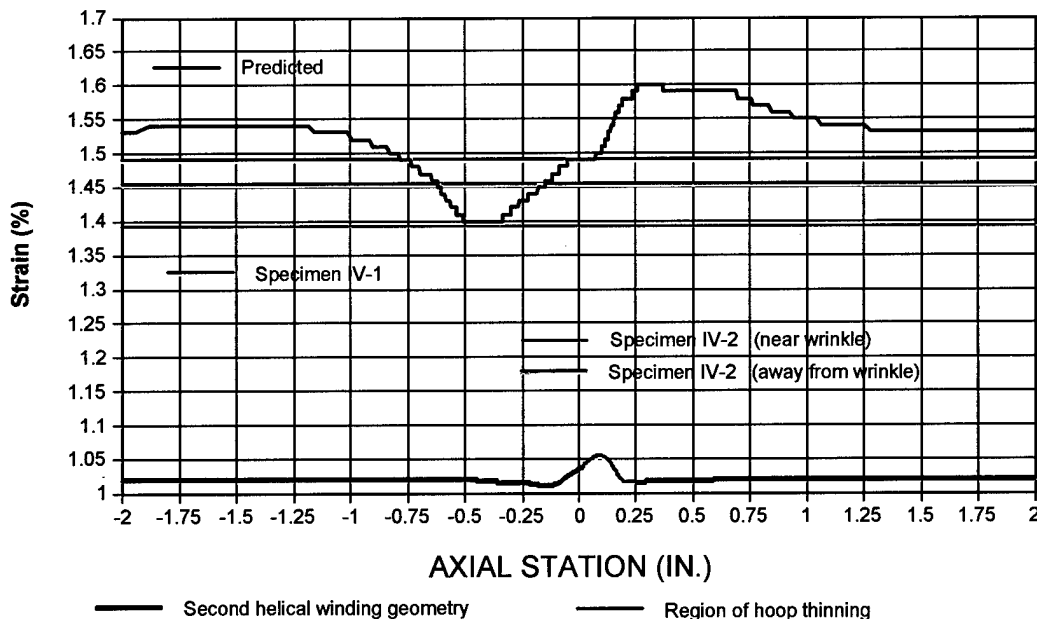
Figure 6.8. Outer surface hoop strains in 12-ply tube with a helical wrinkle, scaled to 7675 psi internal pressure.

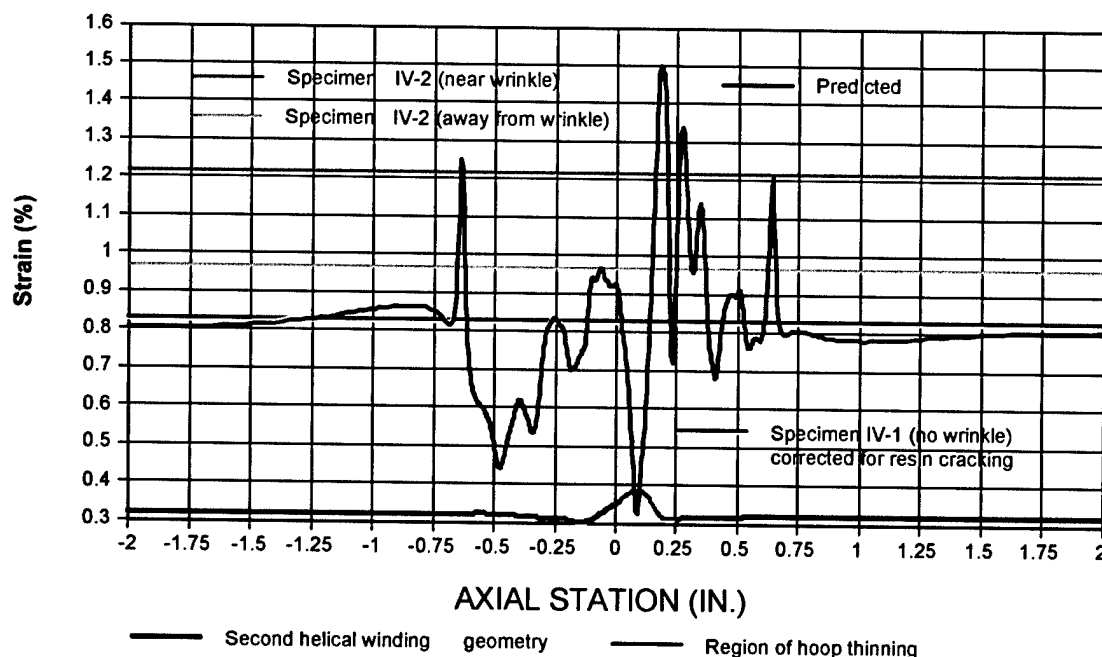
Figure 6.9. Outer surface axial strains in 12-ply tube with a helical wrinkle, scaled to 7675 psi internal pressure.

The corresponding results for the axial strain gages are shown in Figure 6.9. The measured axial strain for the unwrinkled tubes at burst (specimen IV-1) was actually 0.92%. However, during the ramp in pressure there was an abrupt change in strain of +0.1%. This may have been due to local resin cracking beneath the gage since the outer hoop ply is weak in the axial direction. When this abrupt change in strain is subtracted from the measured strain at burst, then scaled to 7675 psi, the resulting strain is 0.82%. This value is within 3% of the predicted strain of 0.80%. Thus, there is again excellent agreement between the test and analysis results for an unwrinkled specimen.

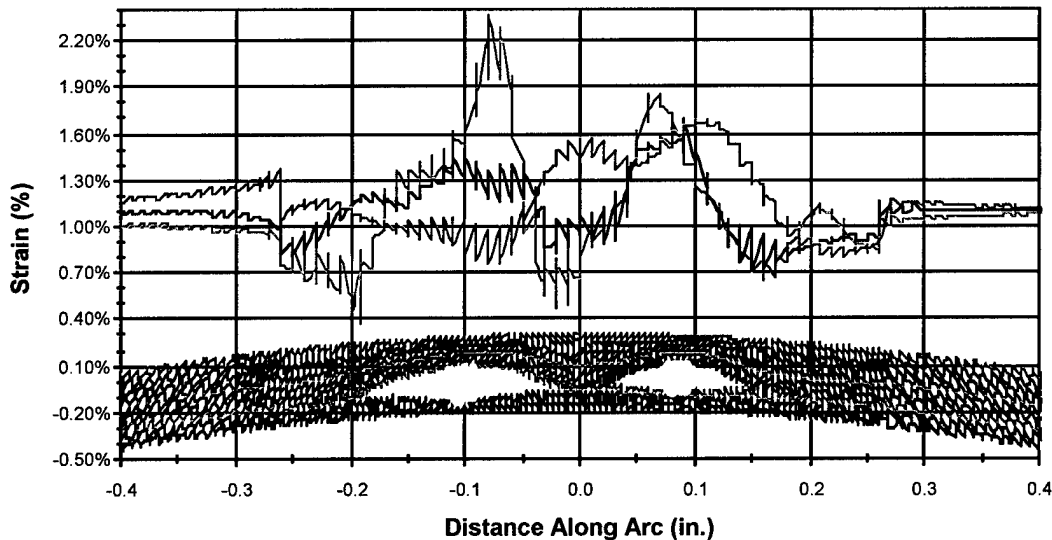
Figure 6.10. Predicted hoop fiber strains for hoop wrinkled tube ran at 2716 psi.

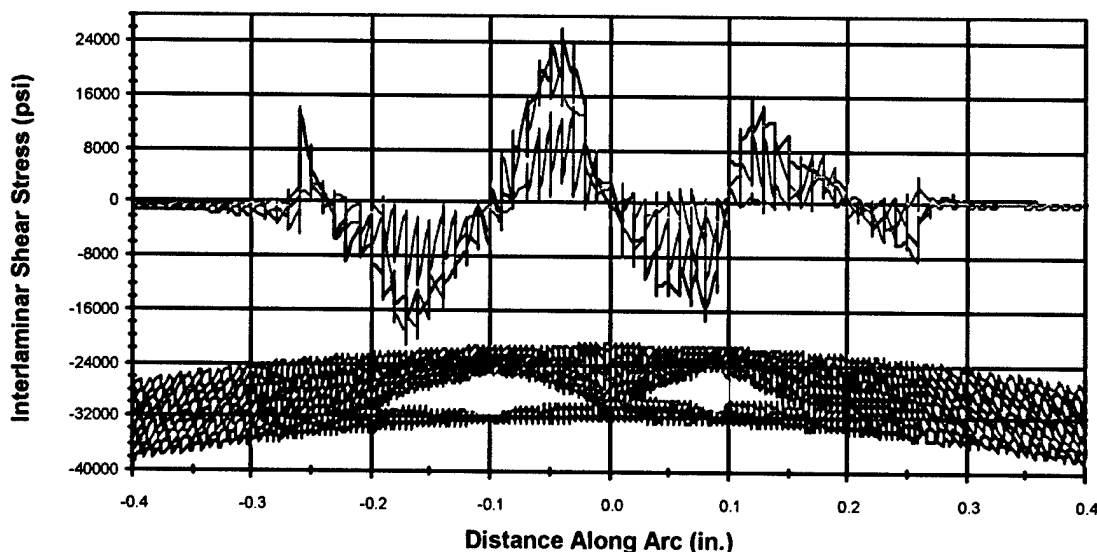
Figure 6.11. Predicted interlaminar shear stresses for hoop wrinkled tube ran at 2716 psi.

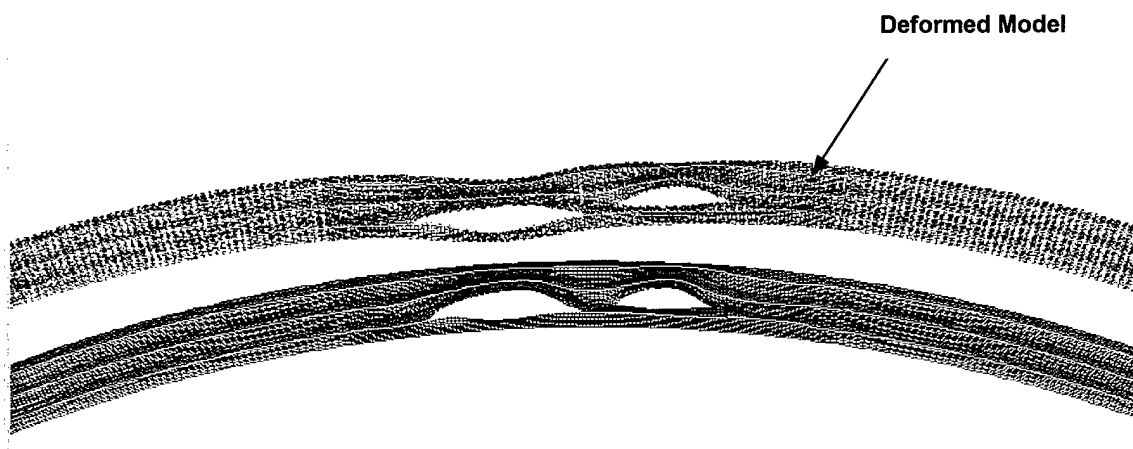
Figure 6.12. Displacement results with 15% magnification.

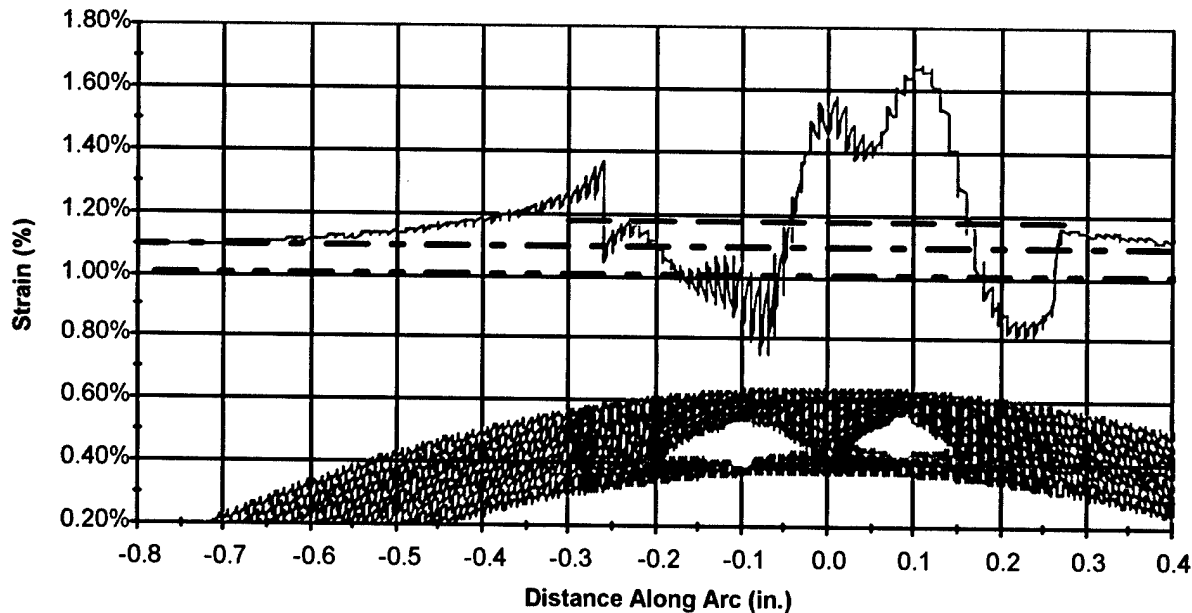
Figure 6.13. Outer surface hoop strains in 9-ply tube with hoop wrinkles.

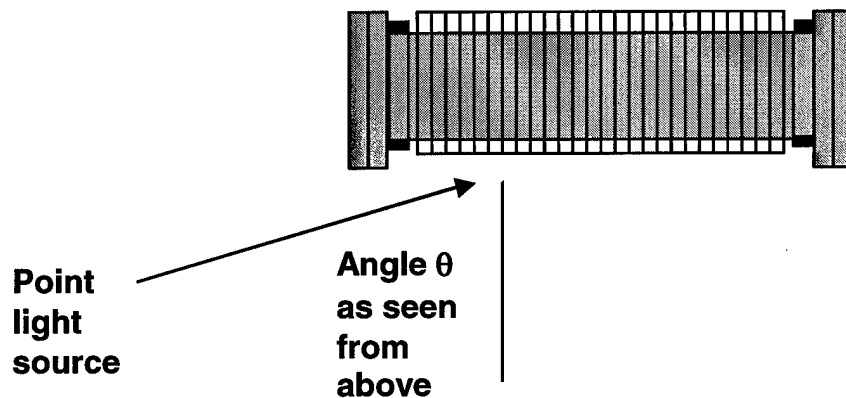
Figure 7.1. A cylindrically curved grating with grating lines perpendicular to the cylinder axis is placed in close contact with the surface of the cylindrical tube. The angle θ is the normal incidence angle in the plane defined by the light source, tube axis, and camera observation location.

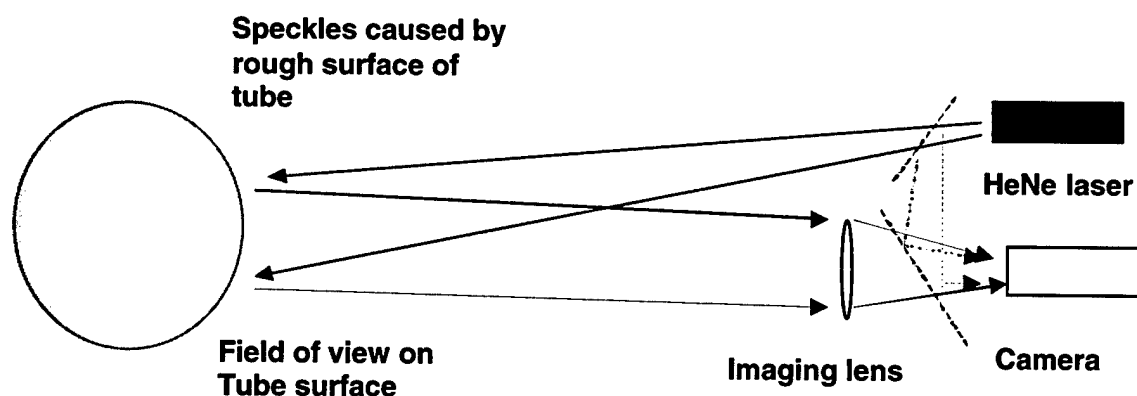
Figure 7.2. Schematic for speckle interferometry. The interference of the reference beam with the image of the scatter beam from the test object is recorded by the camera. Two images, one with no deformation and the other with deformation, are subtracted to give the interference fringes.

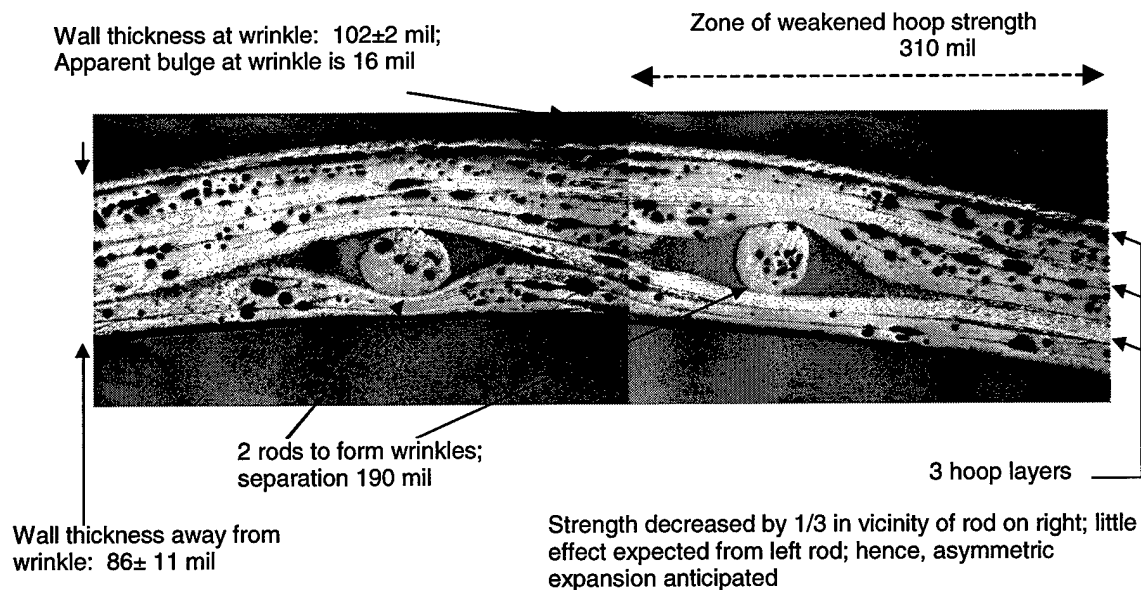
Figure 7.3. Cross section of 4-in. tube with hoop wrinkle. There are 3 hoop layers of which a single layer, the innermost, is under the right hand rod.

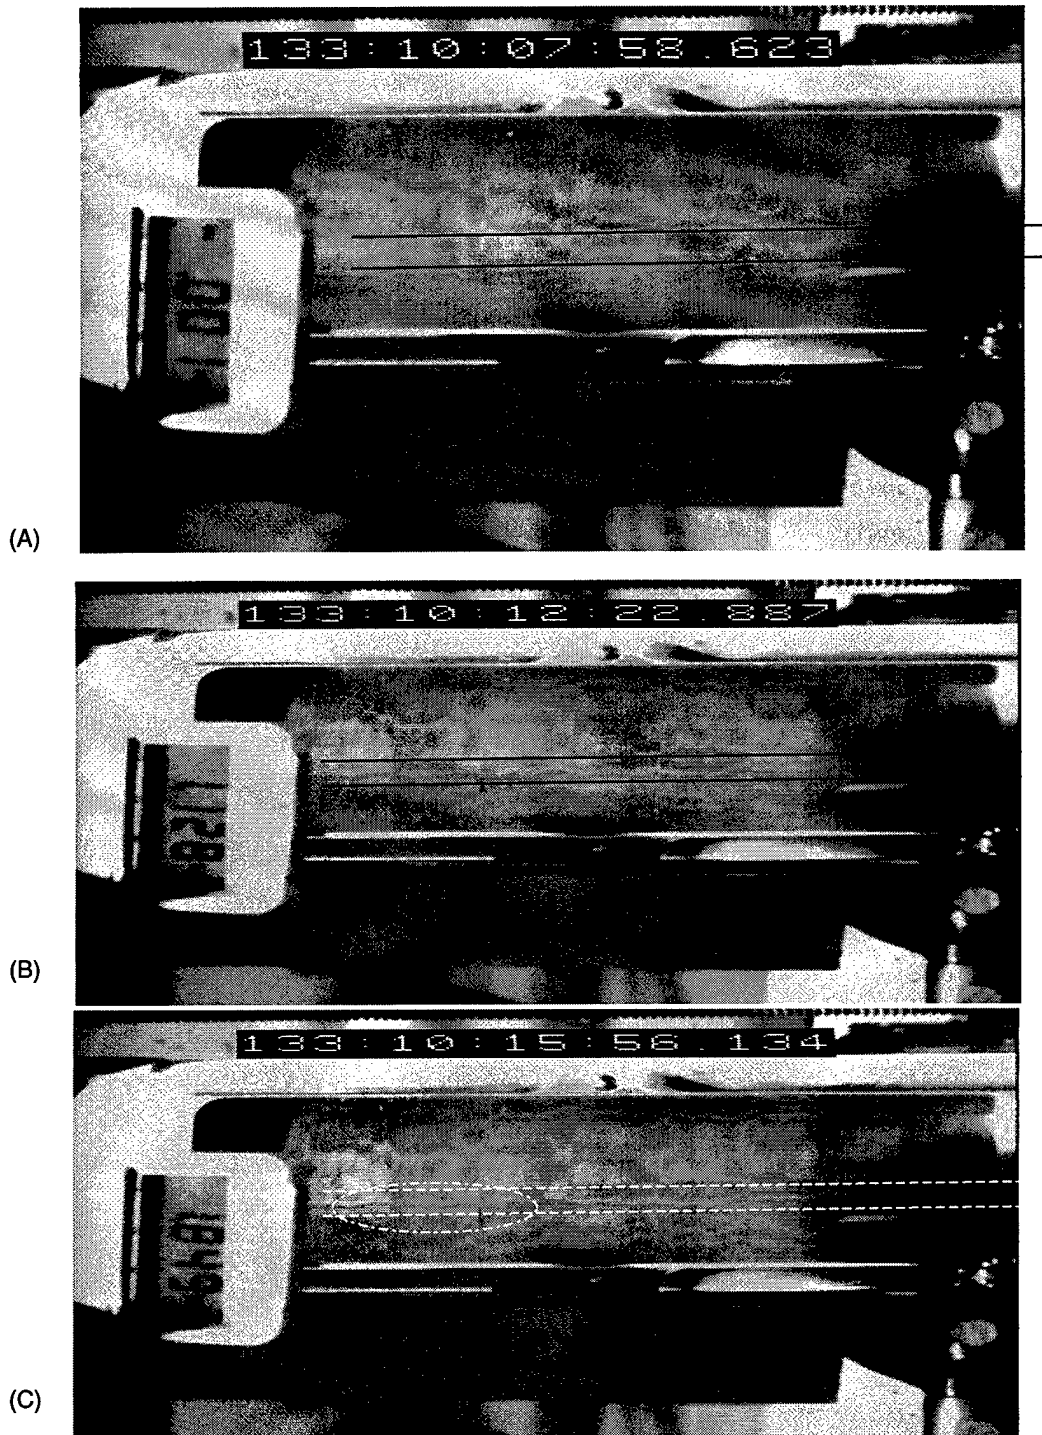
Figure 7.4. Moiré image of size 2.8 in. (v) and 8 in. (h). The dashed lines indicate the rod forming the hoop defect. There are periodic discontinuities formed by steps in the outer epoxy coat from a helical tape wrap. Pressures are (A) 0 psi, (B) 1500 psi, and (C) 2500 psi. The elliptical zone in (C) is where this tube eventually burst at 2695 psi. From 1500 psi upward, a ridgeline is observed coinciding with a rod causing the hoop defect. It is on this ridgeline that the sample eventually ruptured.

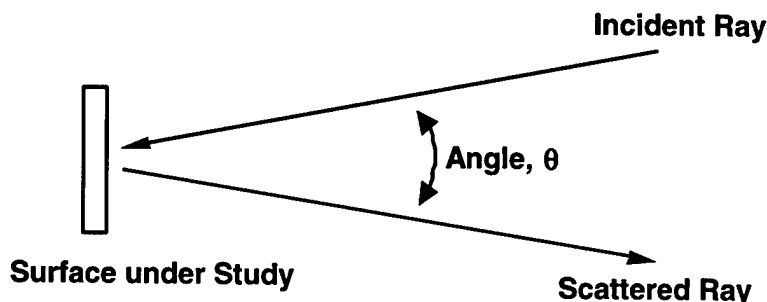
Figure 7.7. Geometry of speckle scattering.
